## Case 387 : Narrative

Case Vehicle (A): 2003 Chevrolet
Type: S-10 ZR5, 4-door, 4x4 pickup
Driver: 51-year-old male
CDC: 12-RPES-1, 12-LZAW-3, 12-FYEW-6

Case No.: 387-03  
Case Vehicle (A): 2003 Chevrolet  
Type: S-10 ZR5, 4-door, 4x4 pickup  
Driver: 51-year-old male

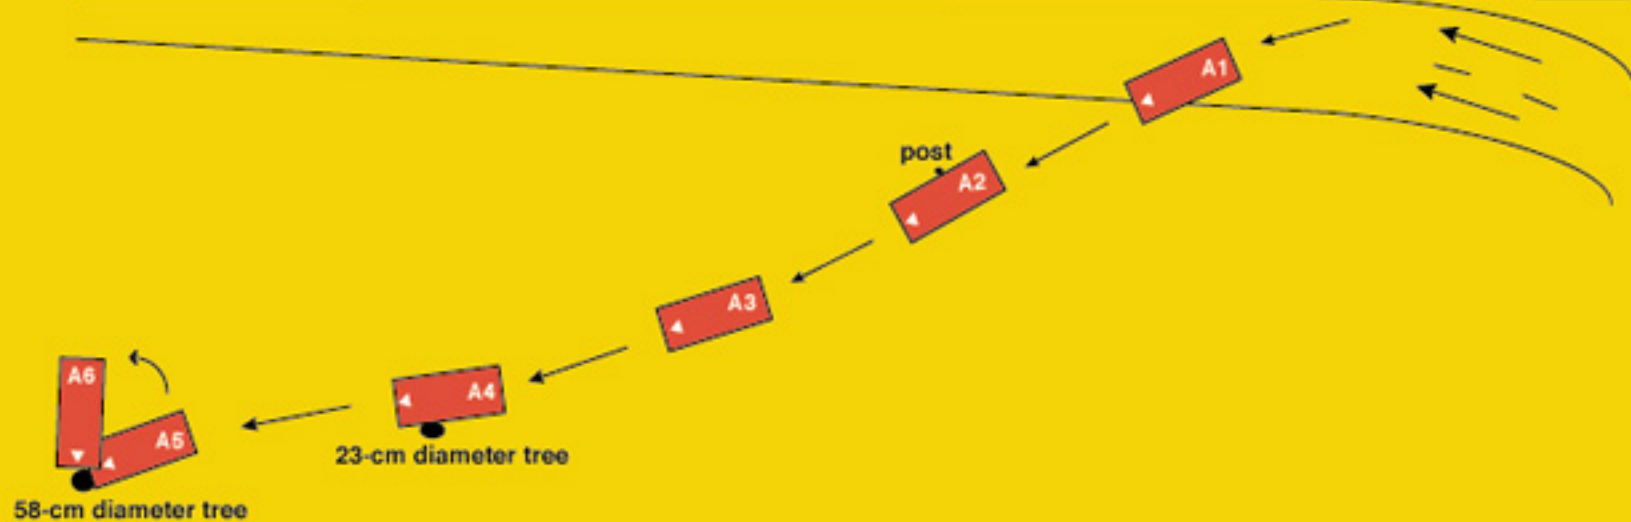
Light Conditions: Daylight  
Weather: Cloudy  
Road Surface: Dry  
Road Construction: Asphalt

North  
↑

Posted Speed Limit 55 mph (89 kph)

[1](#) [2](#) [3](#) [4](#) It was daylight and the sky was cloudy, but the road surface was dry and free of defects as case vehicle (A), a pickup truck, was traveling west at about 70 mph (113 kph) (based on EDR data) in the westbound lane of a three-lane, one-way, divided asphalt roadway with a posted speed limit of 55 mph (89 kph). Due to a brain aneurysm that was revealed at autopsy, the driver lost consciousness and case vehicle (A) departed the roadway, went down a slight grassy incline, traveled southwest for 23 meters, and [5](#) scraped a metal post with the right side. [6](#) [7](#) [8](#) Case vehicle (A) then continued another 45 meters in a southwest direction and struck a tree with the left side, causing the left side of the cargo box to be torn off. [9](#) [10](#) [11](#) [12](#) [13](#) [14](#) [15](#) Case vehicle (A) continued in a southwest direction for another 90 meters until the front end struck a 58-cm diameter tree. Upon impact, case vehicle (A) rotated 90 degrees counterclockwise, and came to rest facing south against the tree. Case vehicle (A) was towed from the scene due to damage.

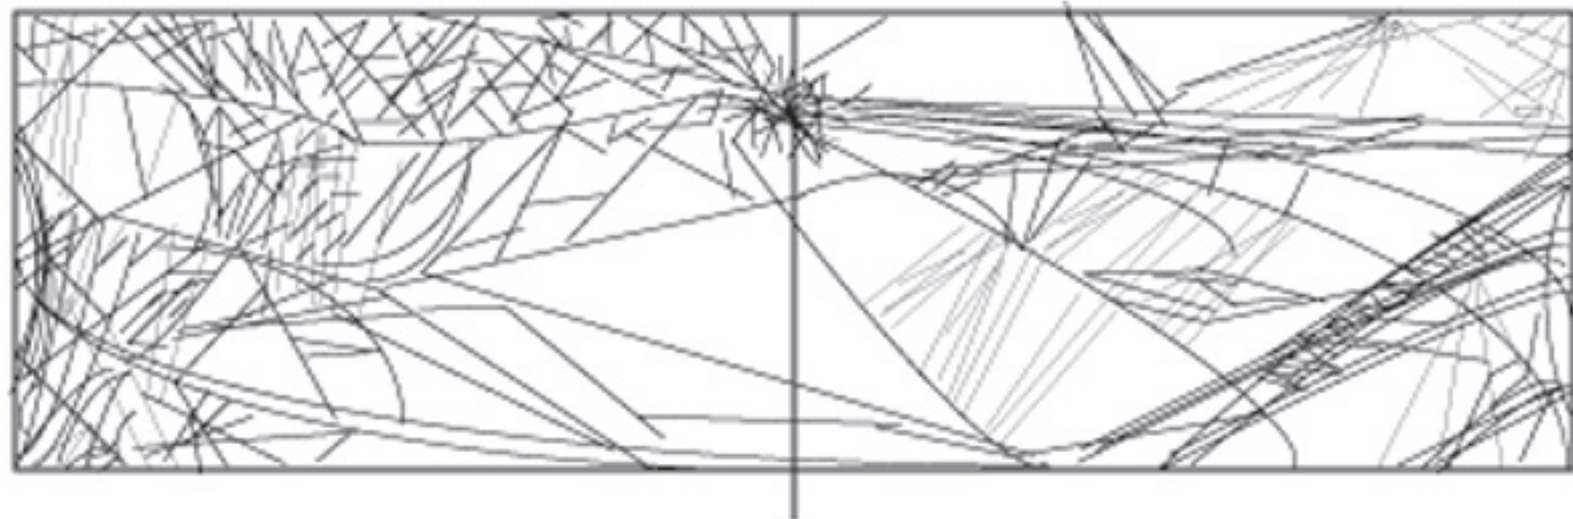
## WINDSHIELD MARK ON CASE VEHICLE:

1 = Definitely 2 = Probably 3 = Possible

2003 S-10

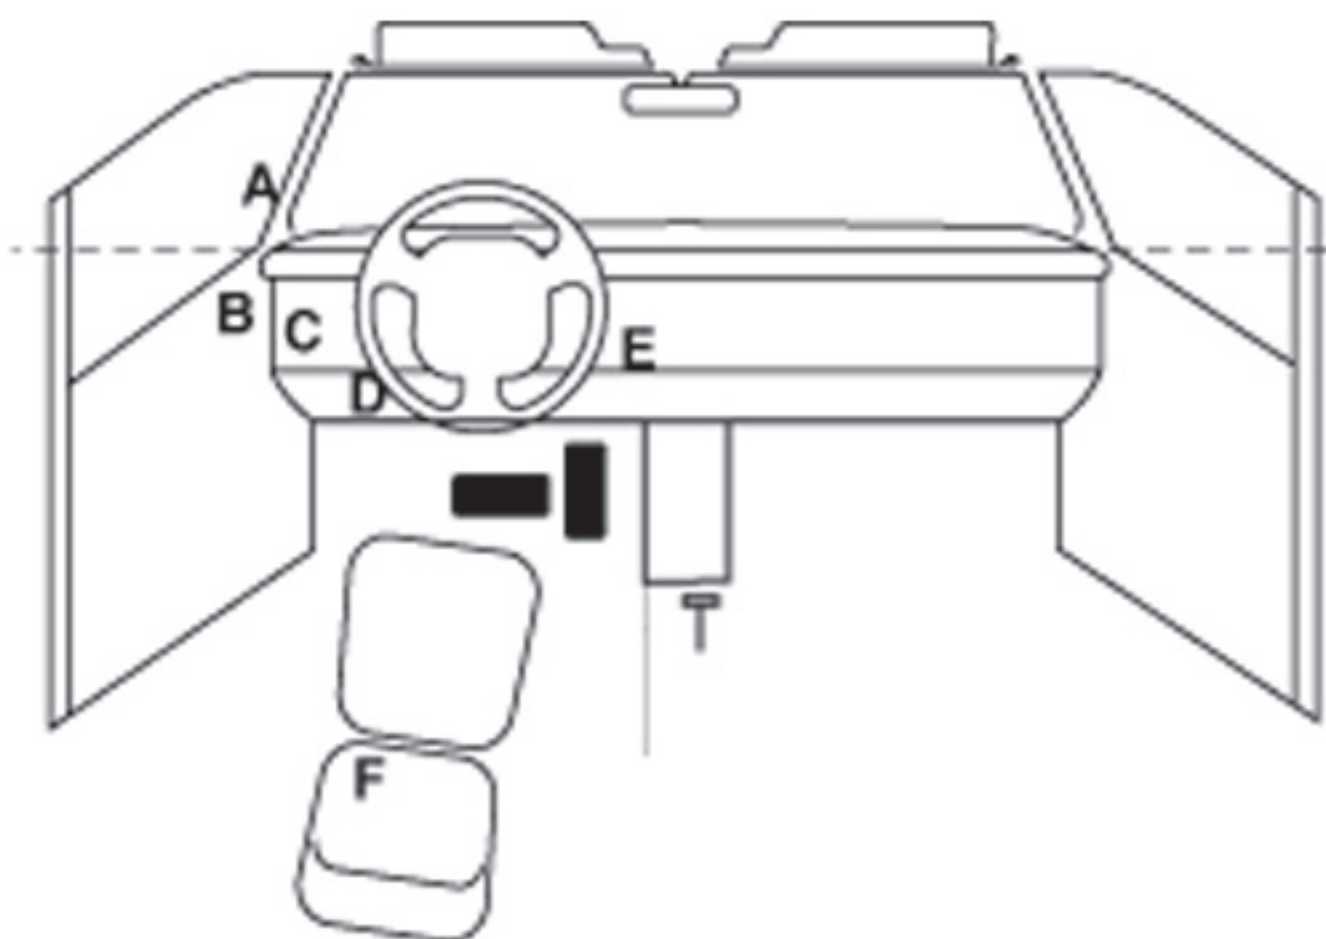
## OCCUPANT CONTACT WORKSHEET

Contact	Interior Component Contacted	Occupant No. if Known	Body Region if Known	Supporting Physical Evidence	Confidence Level of Contact Point
A	A-pillar	DR	Left forearm	Scuff mark	3
B	Door panel	DR	Left leg	Scuff mark	2
C	Instrument panel	DR	Left forearm	Scuff mark	3
D	Knee bolster	DR	Left knee	Scuff mark	2
E	Vertical console	DR	Right knee	Scuff mark	2
F	Seatback	DR	Buttock	Fabric transfer	1
G					
H					
I					
J					
K

**A= A-pillar, scuff mark**

**B= Door panel, scuff mark**

**F= Seatback, fabric transfer**

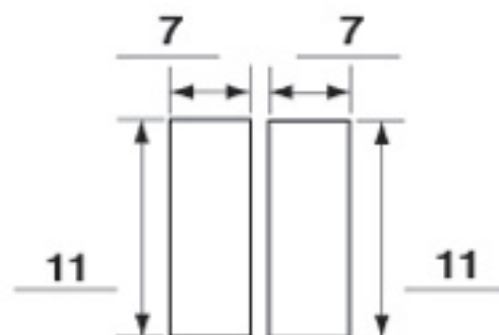
Driver Airbag Doors

I-Pattern

Vents: ☒ Y ☐ N  
if yes, how many: 2

Tethers: ☒ Y ☐ N  
if yes, how many: 2

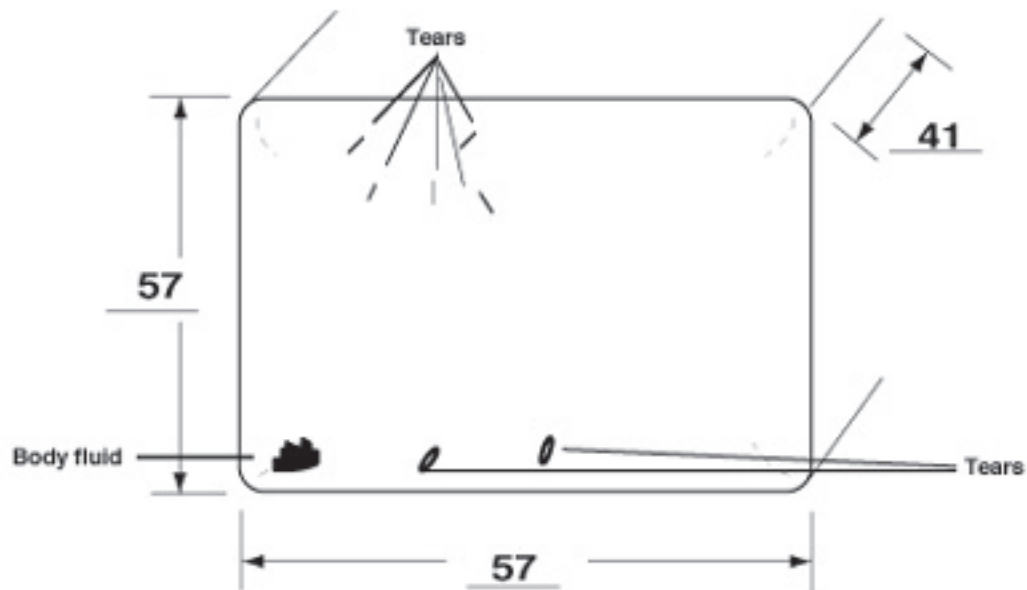
Passenger Airbag

Vents: ☒ Y ☐ N

If yes, how many: 2
